ASBESTOS SURVEY

Wahoo City Hall/Police Station

605 North Broadway

WAHOO, NEBRASKA

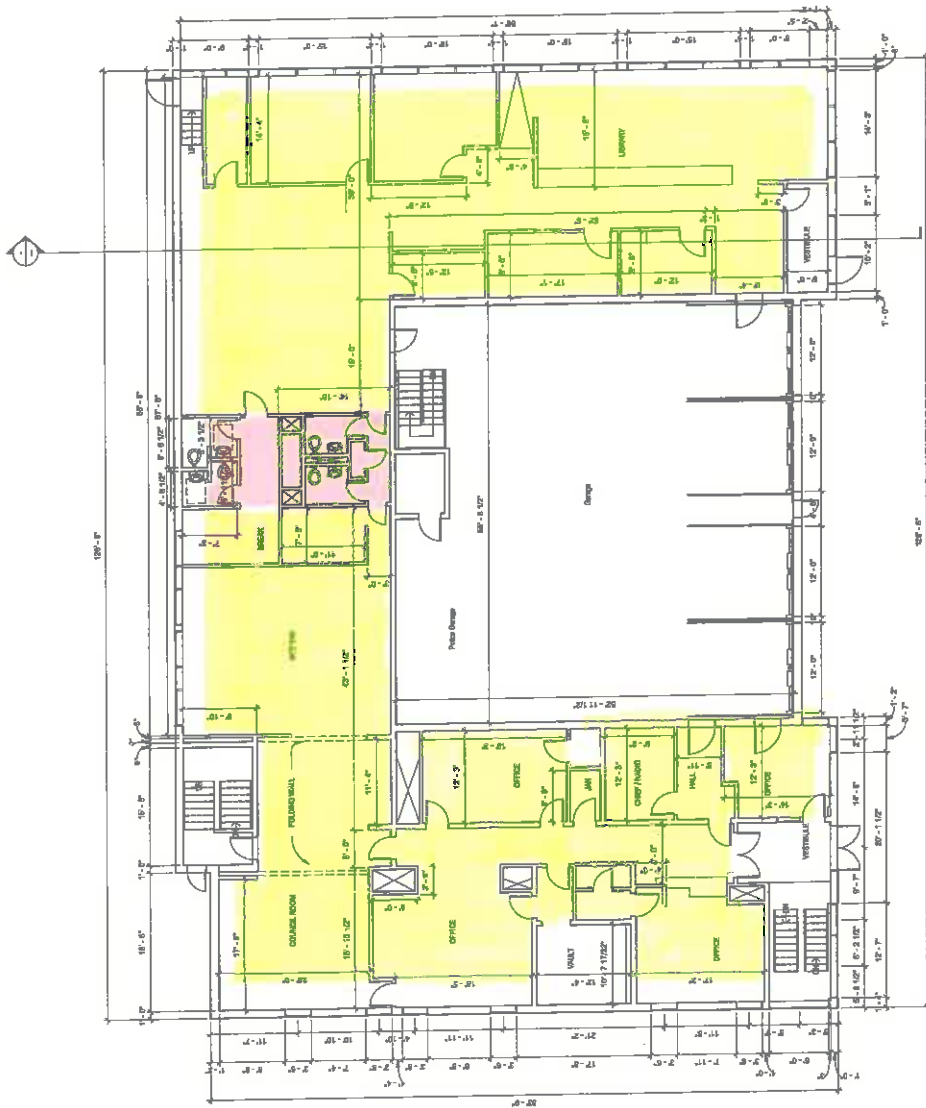
① First Floor Plan
1/8" = 1'-0"

Black Mastic (Sample 23)

Location: Misc. rooms S-W side of main level (under carpet)
See drawing in Appendix A
Quantity: Approx. 1,300 square feet

Black Mastic (Sample 27)

Location: Misc. rooms and hall in police station
See drawing in Appendix A

Black Mastic (Sample 29)

Location: Misc. areas in police station (under carpet)
See drawing in Appendix A

Asbestos Containing Acoustical Ceilings

Assumed Asbestos Acoustical Ceiling (above drywall)
